## KIT DE RÉTROFIT AVEC DOUCHETTE POUR DOUCHE DE SÉCURITÉ ET LAVEUR D'YEUX HAWS

### RETROFIT DRENCH HOSE KIT FOR HAWS SAFETY SHOWERS AND EYEWASHES

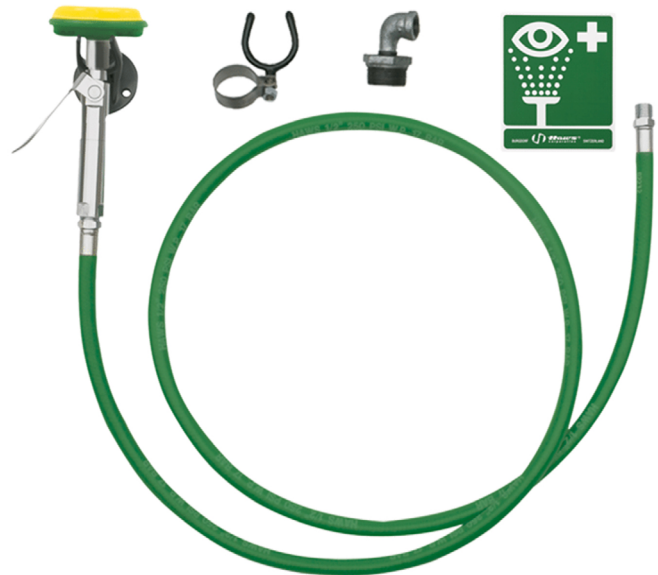
Le Haws EU-8901RFK-AXION est un kit de retrofit avec douchette permettant d'ajouter un dispositif de rinçage manuel à une douche de sécurité ou à un laveur d'yeux existant. Il permet d'effectuer un rinçage ciblé du corps, des yeux ou du visage tout en conservant l'installation déjà en place.

Conçu pour l'adaptation d'équipements existants, le kit EU-8901RFK-AXION comprend les différents éléments nécessaires à son installation, notamment la douchette AXION®, les colliers de serrage, les raccords en T, les raccords et le matériel de fixation. Il permet ainsi de compléter une installation de sécurité sans avoir à remplacer l'ensemble de l'équipement.

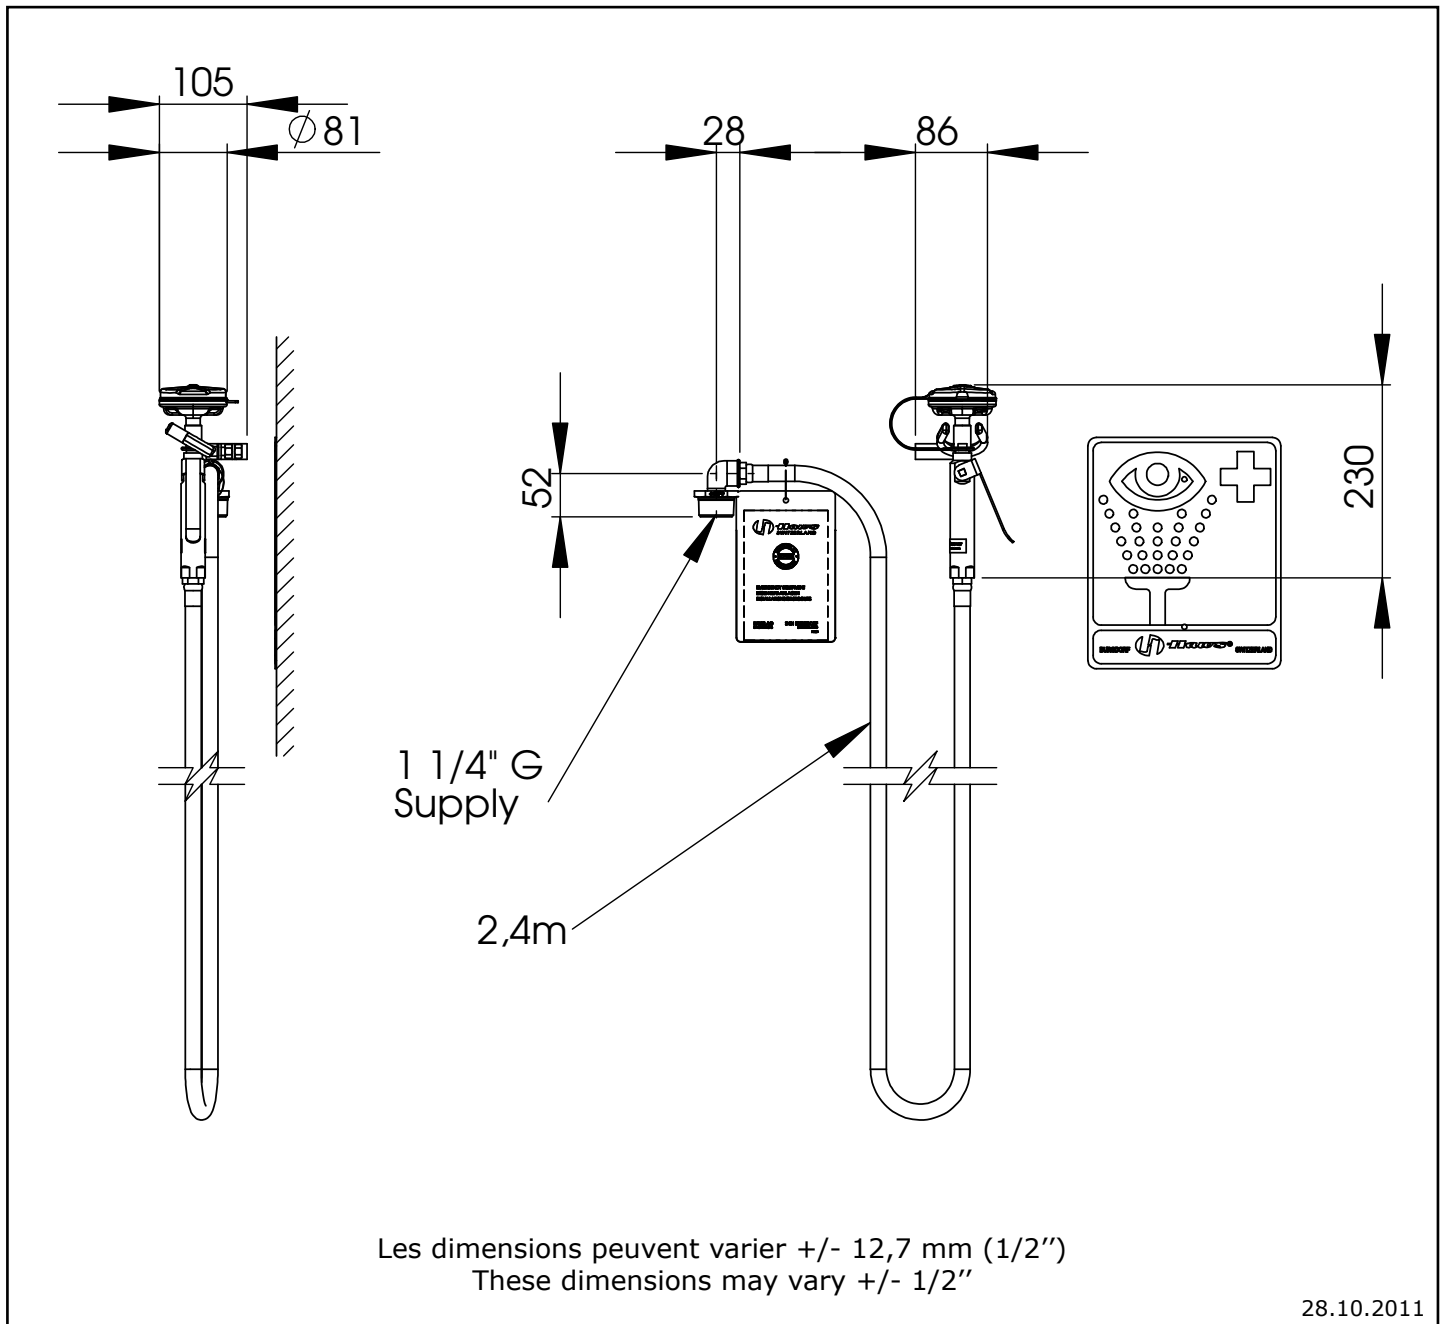
Free access to the eye/facewash & body spray EU-8901RFK-AXION must be guaranteed at all times.  
The operator is responsible for the observance of this requirement.
